TECHNICAL REPORT REMR-CS-11

**IN SITU REPAIR OF DETERIORATED  
CONCRETE IN HYDRAULIC STRUCTURES  
LABORATORY STUDY**

**R. P. Webster, L. E. Kukacka**

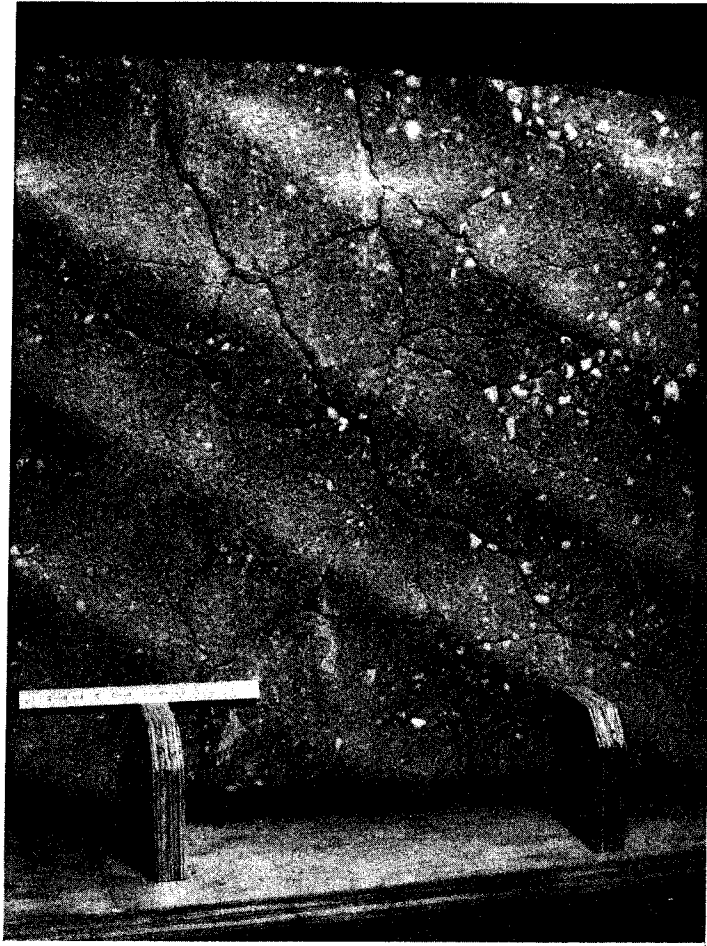
Figure 1. Typical "cracked" concrete slab.

10. The "cracked" slabs were fabricated by casting them individually into sheet metal forms. After the mixture had taken its initial set (3 to 4 hr after being fabricated), the corners of the forms were opened, and the slabs were flexed by hand until cracks began to open up in the surface. Cracks varying in width from hairline to 1/4 in. could be created this way (Figure 1). All slabs were sandblasted prior to being repaired.

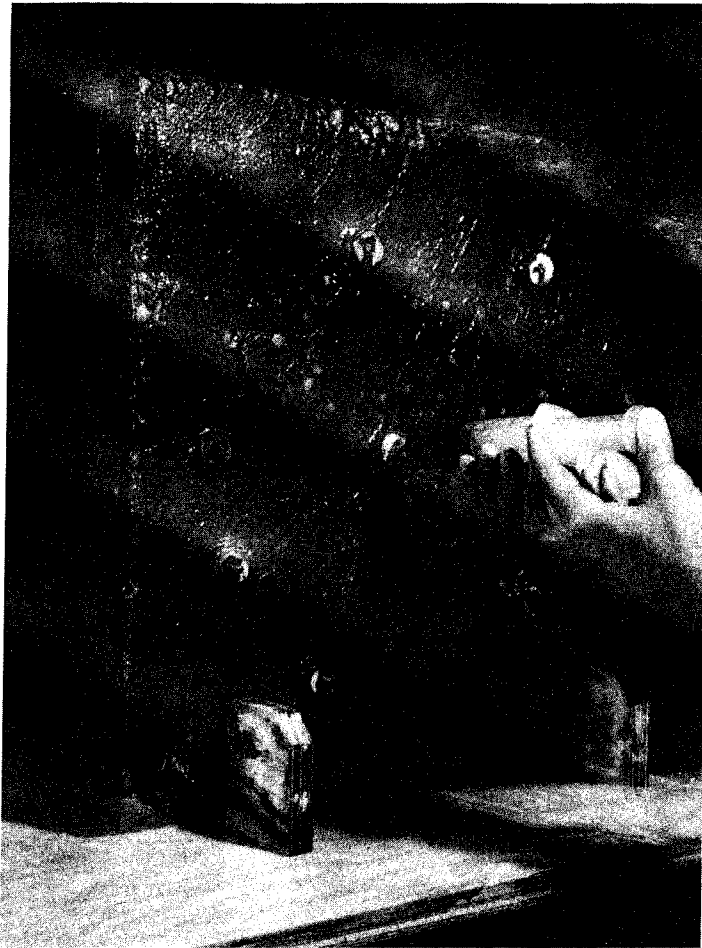
Figure 2. Repair of slab by injection using a plastic syringe.

25. The water-saturated slabs were soaked in water for a minimum of three days between steps 2 and 3. They were then patted dry to a SSD condition before the injection ports (1-in. diam wooden dowel into which a hole had been drilled) were glued to the surface. Because of the small quantities of materials used to repair the slabs, all the injection work was done by hand using plastic syringes (Figure 2).

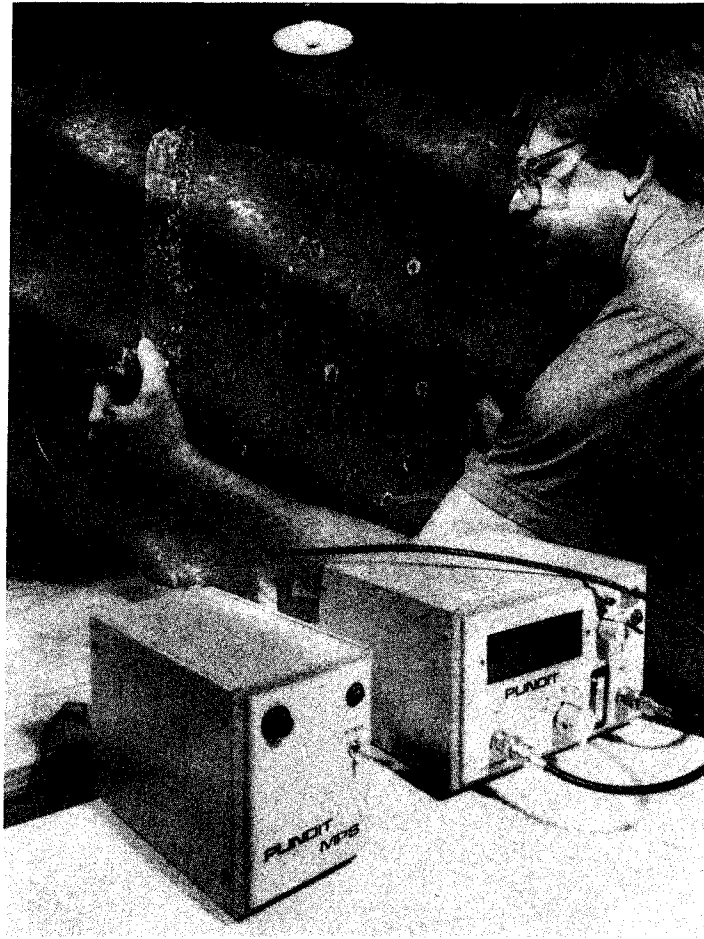
Figure 3. Ultrasonic pulse velocity test.

26. The effectiveness of the repairs was evaluated by visual examination of cores removed from each slab, by means of pre-injection and post-injection ultrasonic pulse velocity measurements, and by splitting tensile strength tests done on discs cut from the cores removed from the repaired slabs.

29. The results of the ultrasonic pulse velocity tests indicate that each of the adhesives was effective in restoring the integrity of the slabs, regardless of whether the slabs were air-dried or water-saturated. The average post-injection pulse velocities of the repaired slabs were all within the range measured for sound, uncracked concrete, i.e., between 14,000 and 15,000 ft/sec. Ultrasonic pulse velocities for sound, uncracked water-saturated concrete are approximately 2% lower than those values measured for sound, uncracked, air-dried concrete.

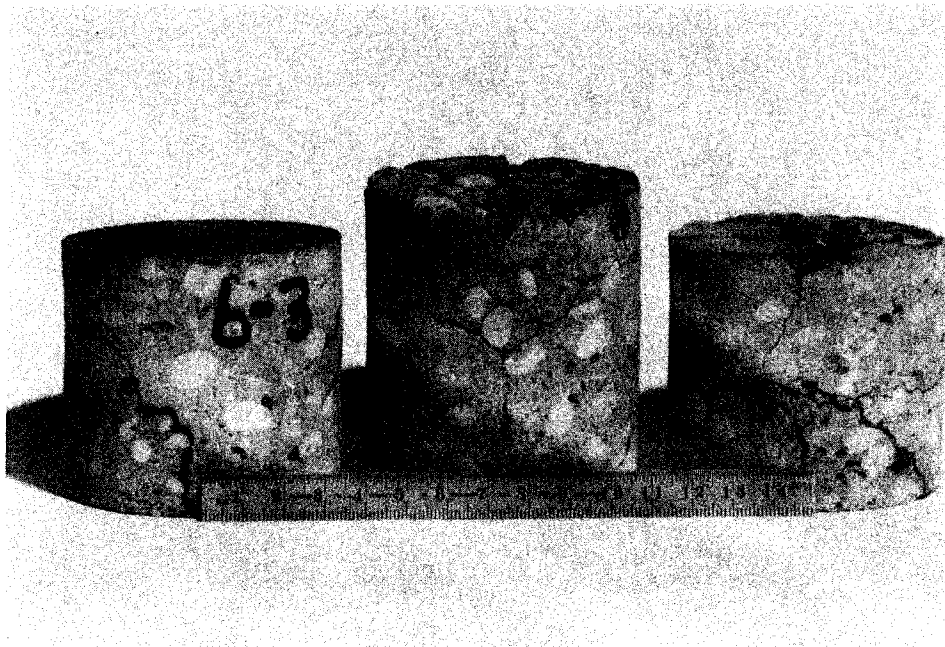
Figure 4. Cores removed from slabs repaired by injection.

30. A visual examination of the cores indicated that with the exception of those slabs which were repaired with the PCM-1100 HMW methacrylate, approximately 95% of the crack network within each slab was filled with

adhesive (Figure 4). The crack network within the slabs repaired with the PCM-1100 contained only 50 to 80% adhesive. Drainage of adhesive from the crack network within these slabs probably was due to the low viscosity and long gel time of the system.

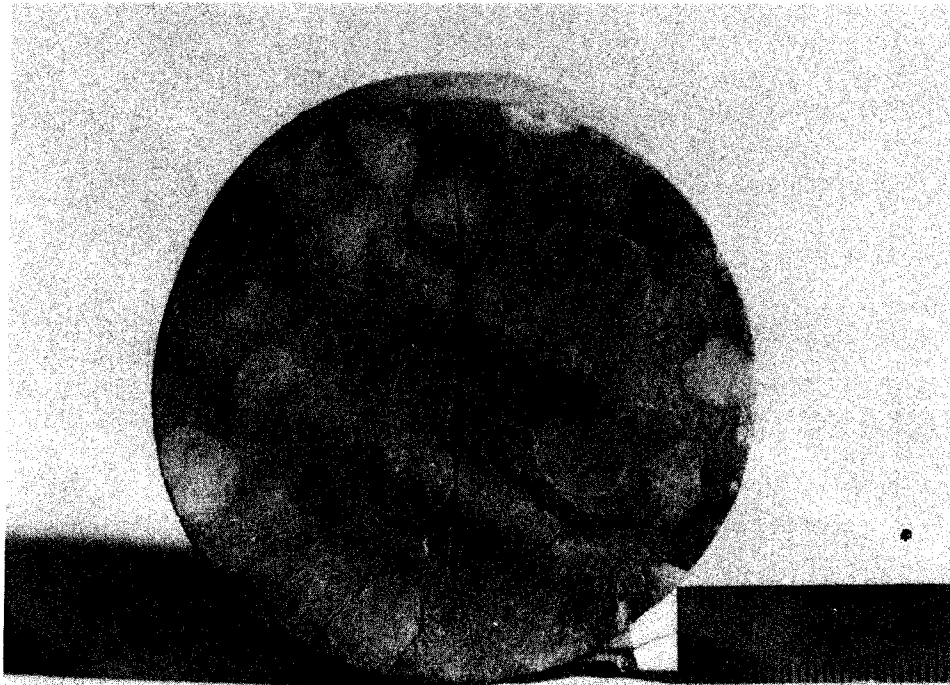
Figure 5. Splitting tensile strength test specimen after failure.

slabs was 703 psi. Concrete used as the control had an average splitting tensile strength of 616 psi. After testing, an examination of the disc cross-sections indicated that failure of the samples generally occurred in a zone outside the filled cracks (Figure 5).

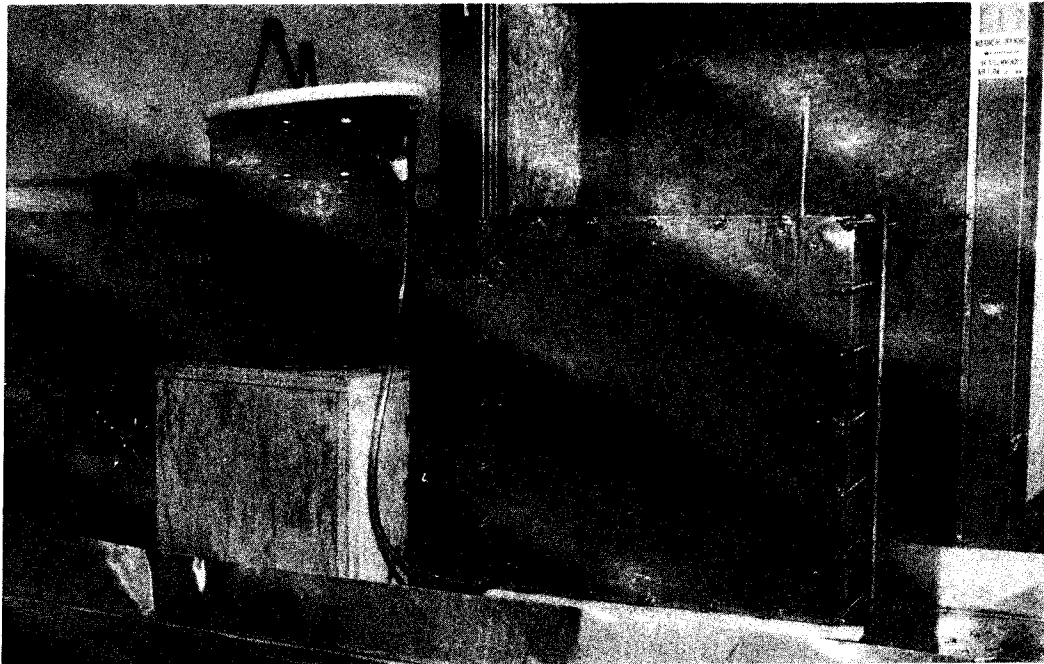
A. Laboratory set-up for vertical impregnation studies.

37. All vertical impregnations were done using a soaking jacket which was braced against the face of the slab (Figure 6). The soaking jacket was made of 0.05 in. thick stainless steel sheet with a 0.5 in. thick stainless steel spacer around the edge of the jacket. A closed-cell polyurethane was used as a gasket material to seal the soaking jacket to the face of the slab. The sides and back of all slabs were coated with a gel epoxy to prevent leakage of monomer during soaking.

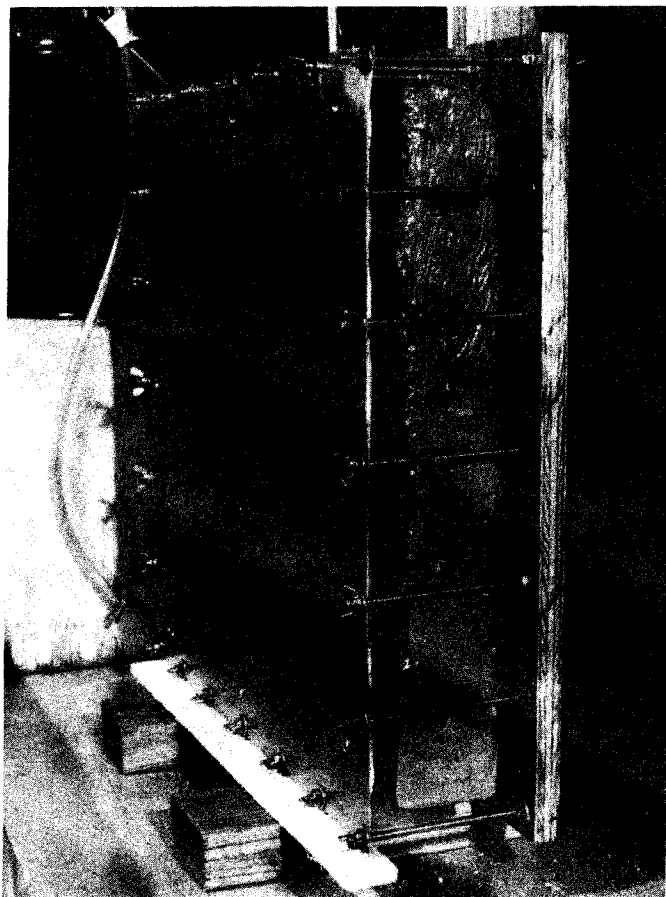
B. Close-up of slab  
inside impregnation  
soaking jacket.

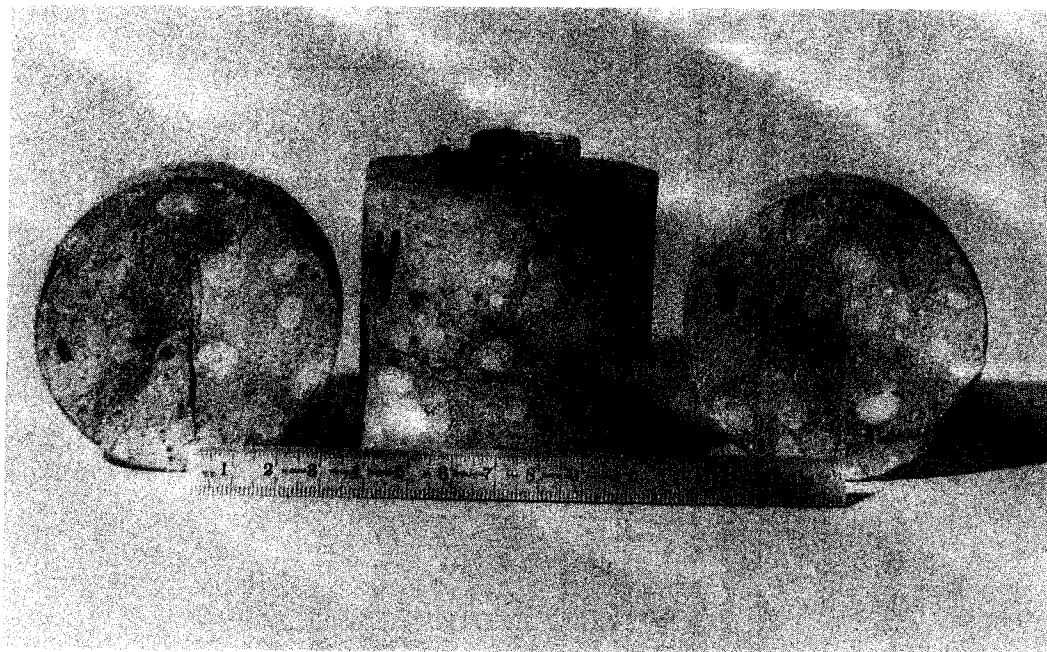
Figure 7. Cores removed from slab repaired by impregnation and injection (darkened areas around cracks indicate polymer impregnated concrete).

43. A comparison of the splitting tensile strengths of the slab which was impregnated and then injected with epoxy and for slabs which only were injected with epoxy indicates that impregnation of the concrete surrounding the cracks resulted in a 24% increase in strength. This comparison demonstrates that the two methods can be used in conjunction to effectively repair and improve the quality of highly cracked concrete.
